FACE FACTS

Man Falls Through Skylight

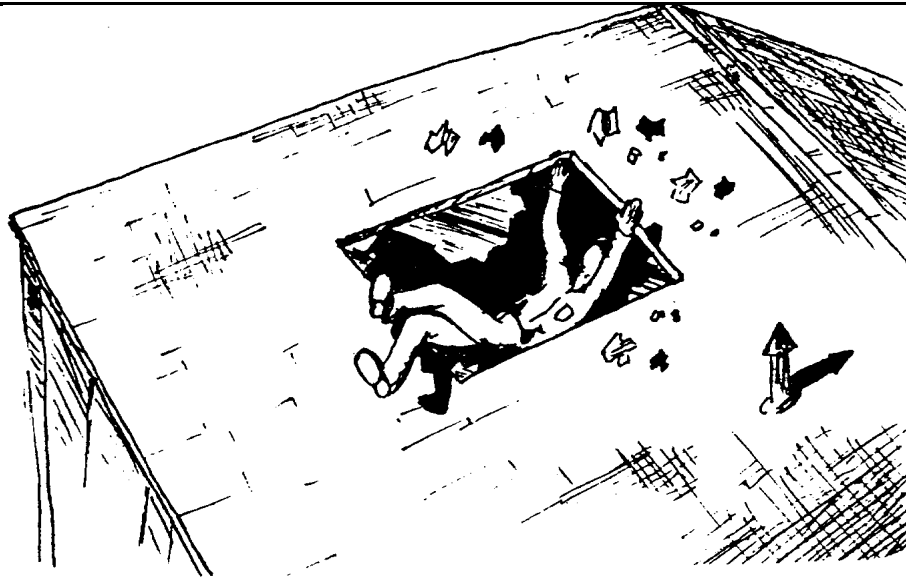
The victim was a member of a roofing crew placing rock on the roof of a school gym. He was on break and walked over to a 36-inch square plexiglass skylight and removed his right shoe and sock. The skylight broke and he fell backwards through the skylight, landing on his head and shoulders. The rescue squad was called and he was rushed to a hospital where he later died. There were nine unprotected skylights on the roof of the gym. The unprotected skylight was just one of many violations found at this particular job site.

- * Employers and workers must strictly adhere to applicable OSHA regulations.
 - Railings or screens guarding all skylights and other openings in roofs must be installed ***before*** roofing work begins and must remain in place until construction is completed, in accordance with 29 CFR 1910.23 and 1926.500.
- * Employers should assure that all workers required to work near roof openings or skylights are adequately trained to recognize the serious hazard of falls through roof openings, and the danger of sitting or stepping on skylights.
